National Aeronautics and Space Administration

NASA-DoD Lead-Free Electronics Project

DRAFT Joint Test Report

July 2011

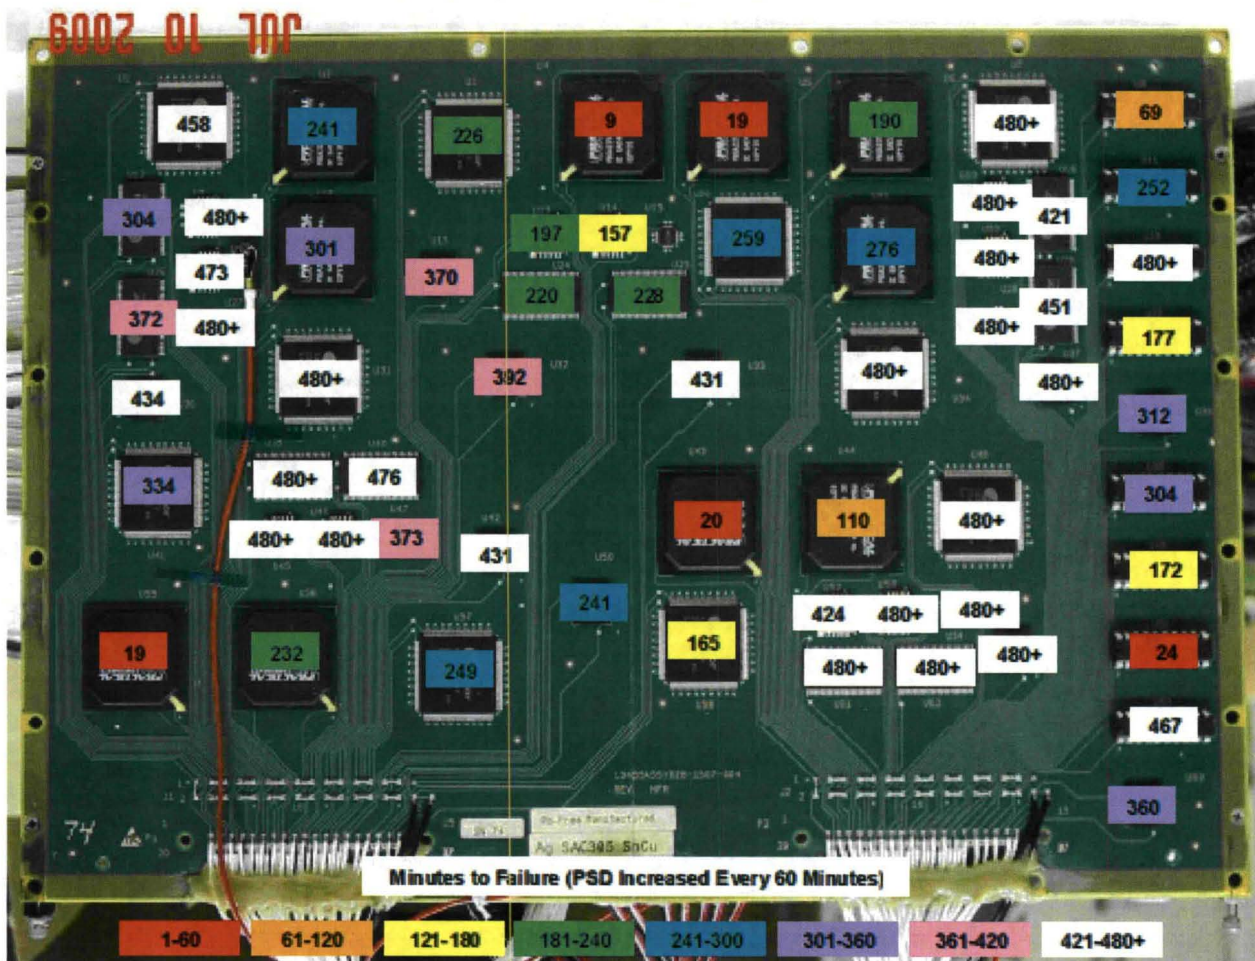
Figure 3 - Test Minutes Required for Components to Fail (Test Vehicle 74 Data)

Figure 3 shows when the components failed on Test Vehicle 74. The failures are colored coded according to how many test minutes were required to cause the failure (red = 1 to 60 test minutes; orange = 61 to 120 minutes; yellow = 121 to 180 minutes; green = 181 to 240 minutes;

blue = 241 to 300 minutes; purple = 301 to 360 minutes; pink = 361-420 minutes; and white = 421 to 480+ minutes). In general, the components tended to fail first down the centerline and along the edges of the test vehicle (near the wedgelocks). Therefore, the first component failures coincide with the regions of highest strain as shown in Figure 4.

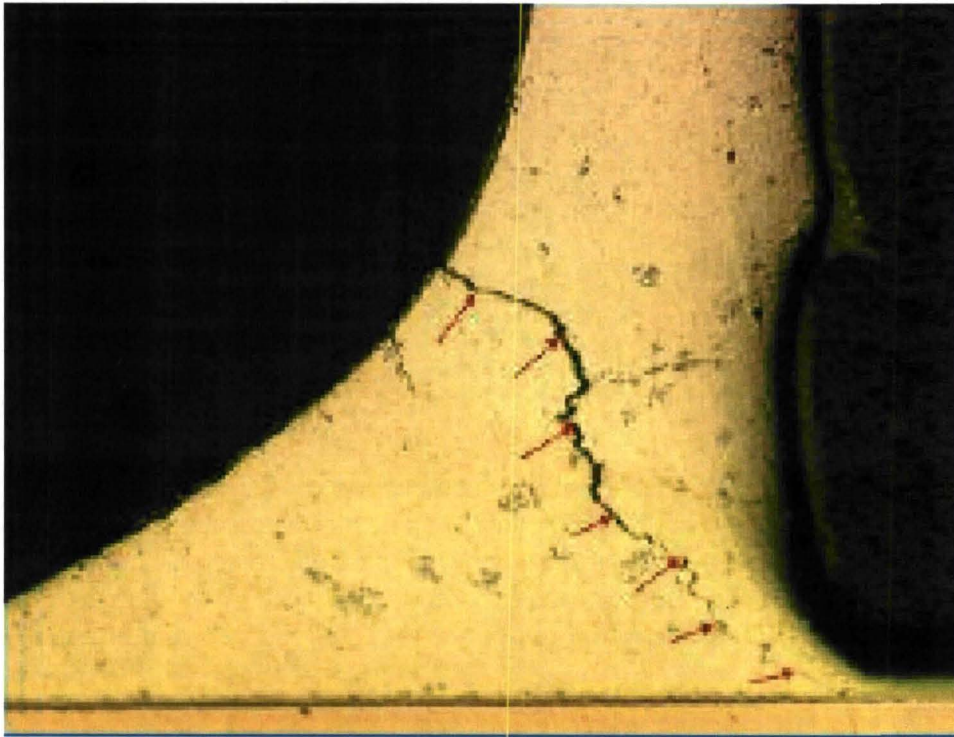
Figure 5 - SN63 U52, Left Side Pad

All of the tested CLCC-20s had SAC305 component finish. None of these solder joints were reworked. Solder cracks we observed around every solder joint. The cross sections of all CCLC-20 packages were performed on corner pads. Each cross section revealed cracking across the length of the solder, see Figure 5. SN67 also showed voiding, in this case the crack traveled along the void, see Figure 6.

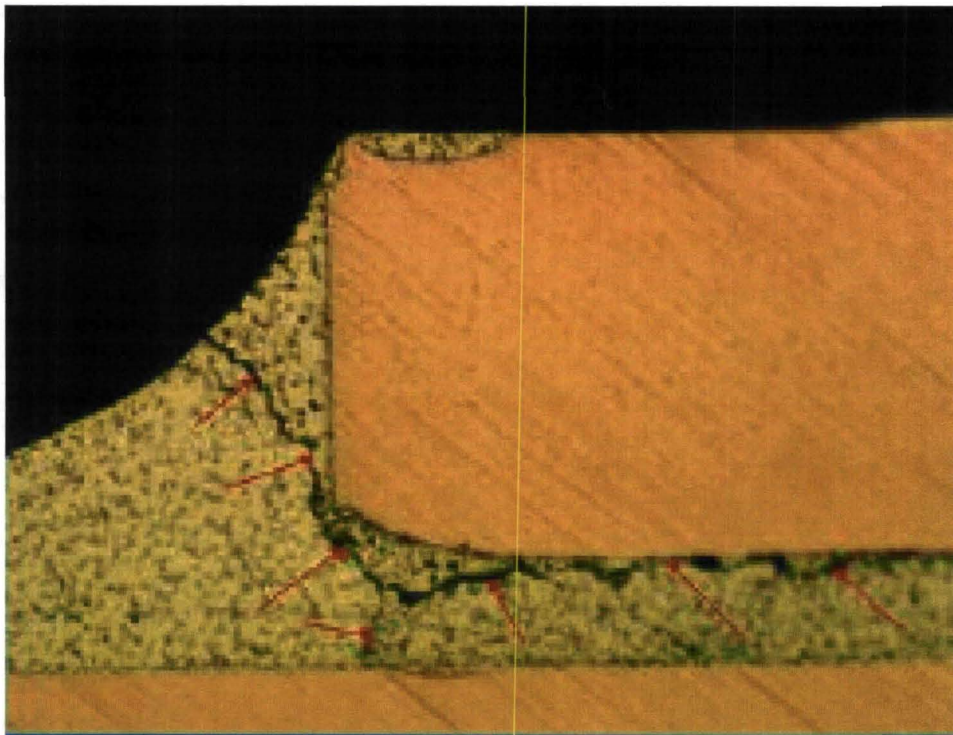
Figure 7 - SN63 U54, Left Side Pad

All of the QFN-20 packages were fabricated using Sn finish and were exposed to one or two reworks with SnPb solder. Approximately half of the solder joints exhibited cracks which ran along the component pad. There does not appear to be a correlation between the cracked solder and the number of re-work cycles to which the part was exposed. Cross sections of the QFN-20 packages reveal that the cracks propagated along the component pad, see Figure 7 and Figure 8.

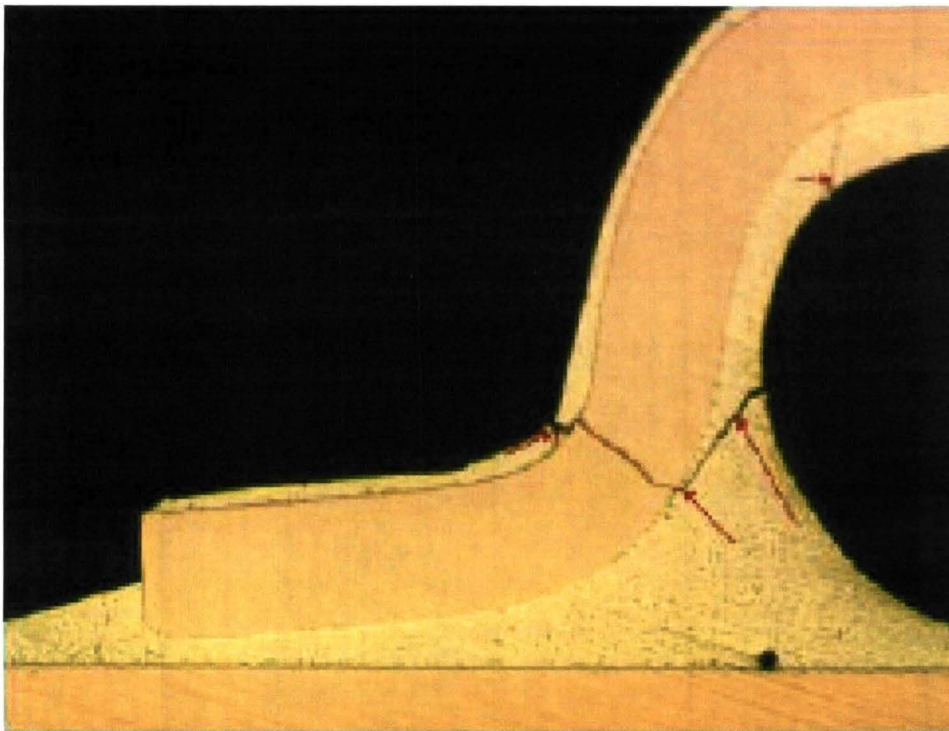
Figure 9 - SN63 U41. Left Lead

Cross-sectioning revealed cracks in the actual copper leads of the TQFP-144 packages. This damage was observed only on parts which were not reworked and therefore the solder joint was Pb-free. This is to be expected as the Pb-free solder is stiffer than the SnPb solder and transfers the stress to the weaker copper leads. Figure 9 and Figure 10 illustrate TQFP-144 packages which were not reworked and therefore contain only Pb-free solders.

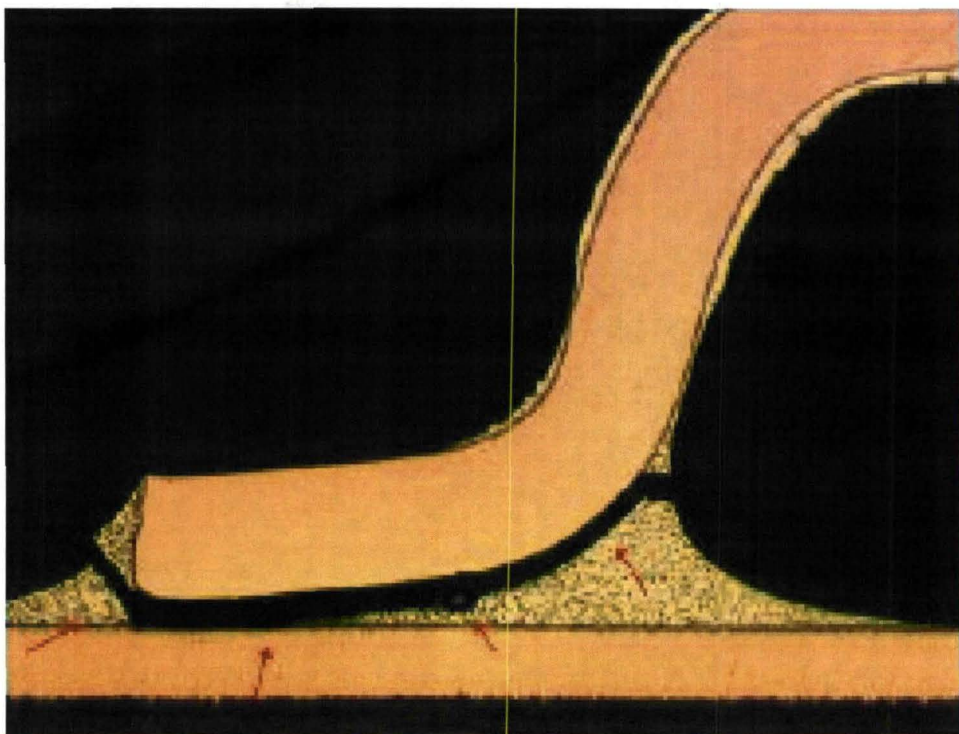
Figure 11 - SN67 U31 Left Lead

Cross-sections of TQFP-144 packages which were re-worked, either once or twice, revealed cracked solder joints in all cases. However, all of the leads on these samples survived, see Figure 11 and Figure 12.

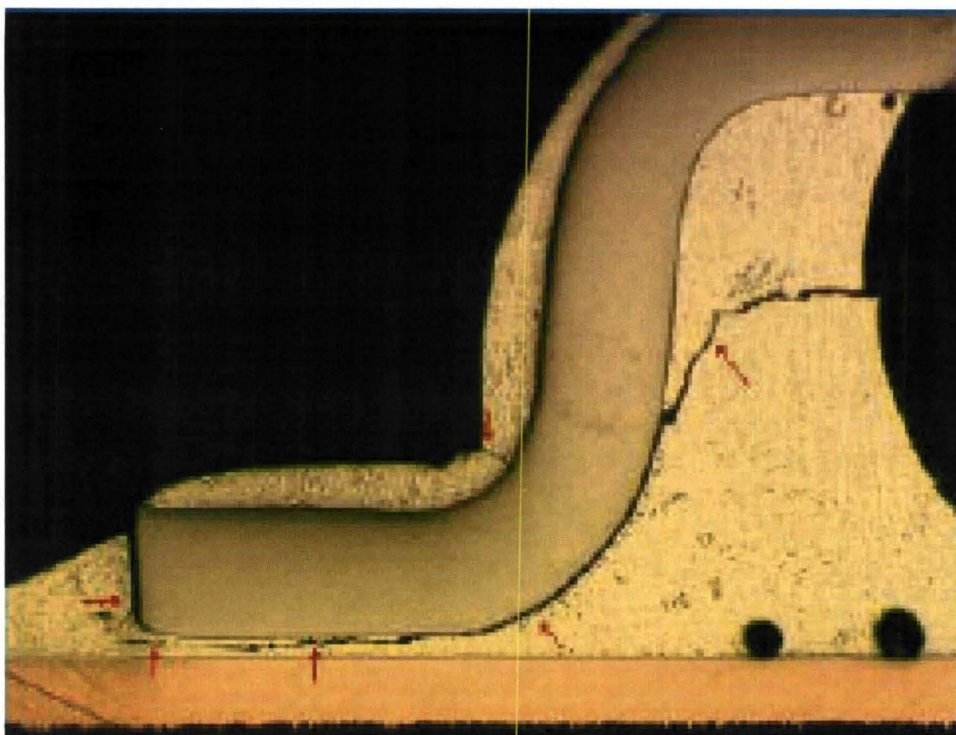
Figure 13 - SN79 U12, Left Lead

SN79 U12 (Figure 13) and SN66 U62 (Figure 14) are examples of TSOPs which did not undergo any re-work. They have Sn and SnBi finishes respectively. Both experienced severe solder cracking in leads on both sides of the component.

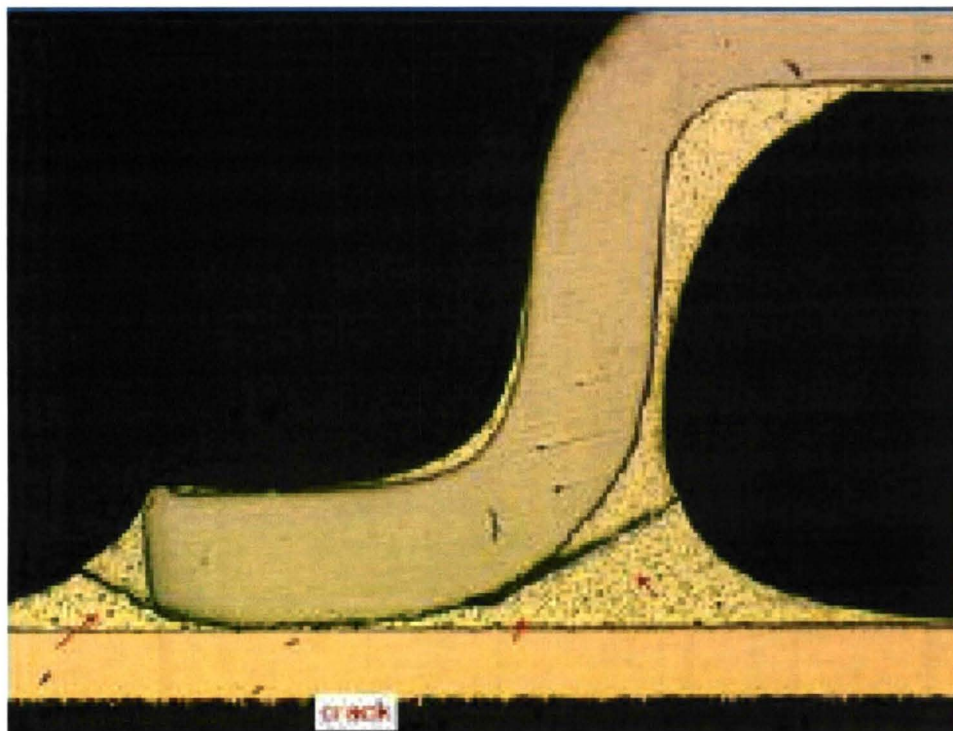
Figure 15 - SN65 U62, Left Lead

showed significant cracking within the solder at both sides of the component. This is consistent with all parts which have undergone one re-work cycle.

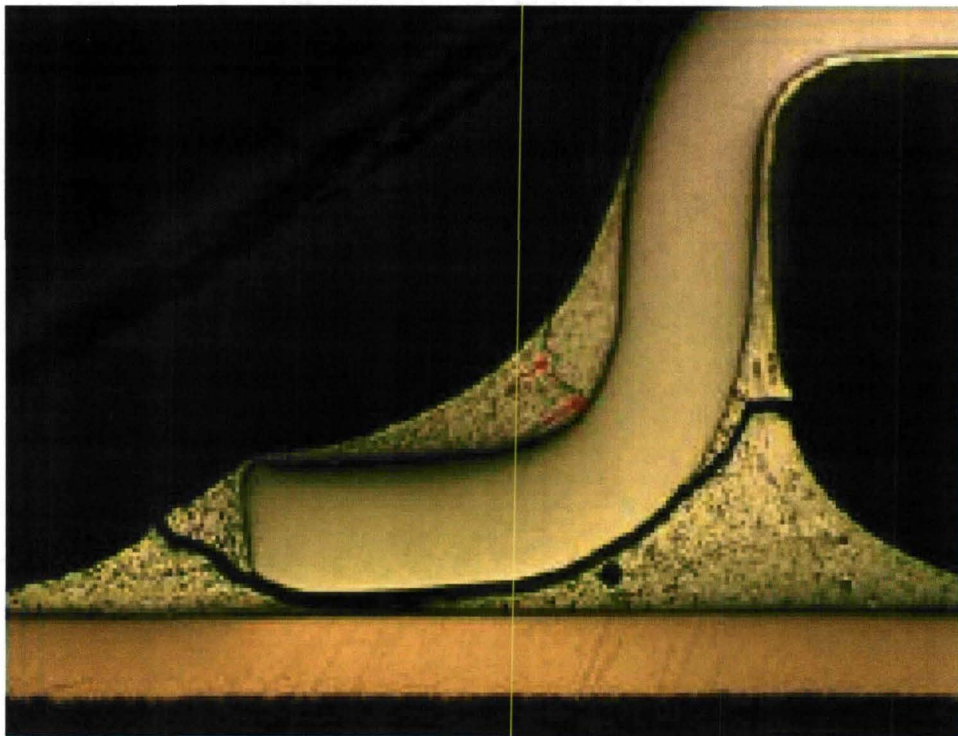
Figure 17 - SN63 U16, Left Lead

SN63 U16 (Figure 17) and SN68 U29 (Figure 18) were both re-worked twice with SnPb solder. SN63 U16 is finished with SnBi and SN68 U29 is finished with Sn. The SnBi part experienced extensive solder cracking through-out. The Sn finished part experienced solder cracking at one side of the component.

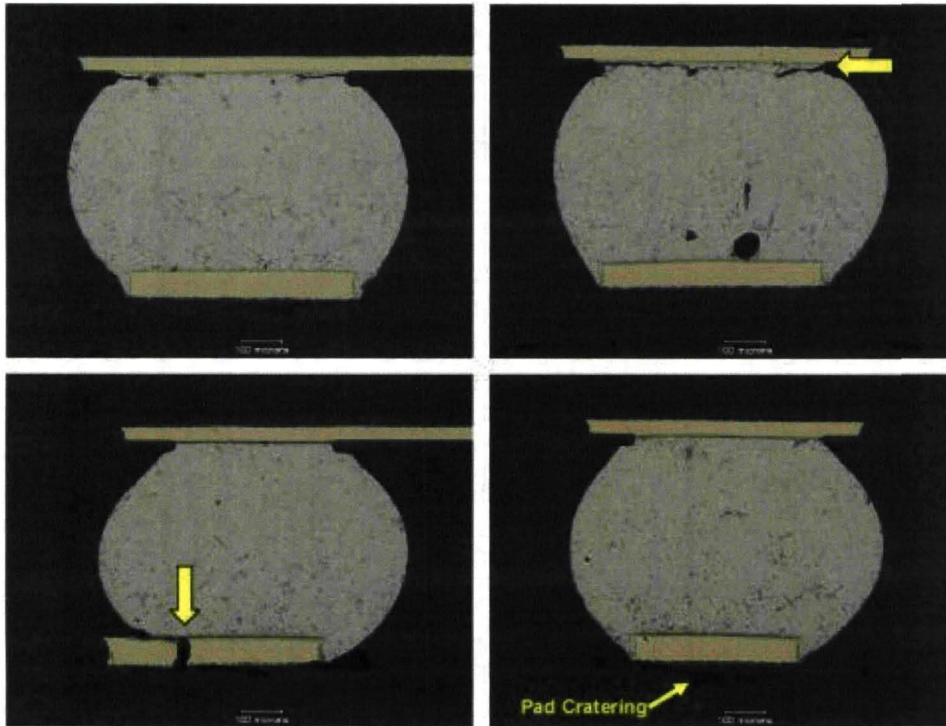
Microsections made at the end of Mechanical Shock Testing showed that the corner solder joints failed first. The SnPb/SnPb sections showed pad cratering, PWB trace cracking, and solder joint cracking on the component side (Figure 20).

Figure 20 - Test Vehicle 34 - Four Corner Balls of BGA U6 (SnPb Solder/SnPb Balls)

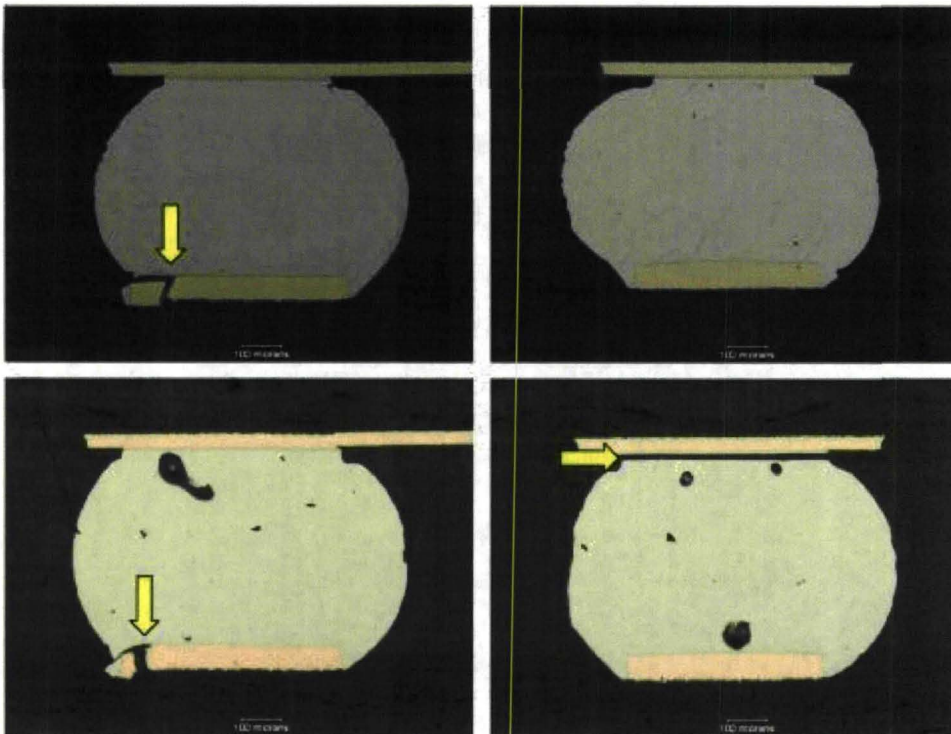
The SAC305/SAC405 sections showed PWB trace cracking and solder joint cracking at the component side intermetallic layer (Figure 21). Which failure mechanism occurred first could not be determined from the microsections.

Figure 21 - Test Vehicle 89 - Four Corner Balls of BGA U2 (SAC305 Solder/SAC405 Balls)

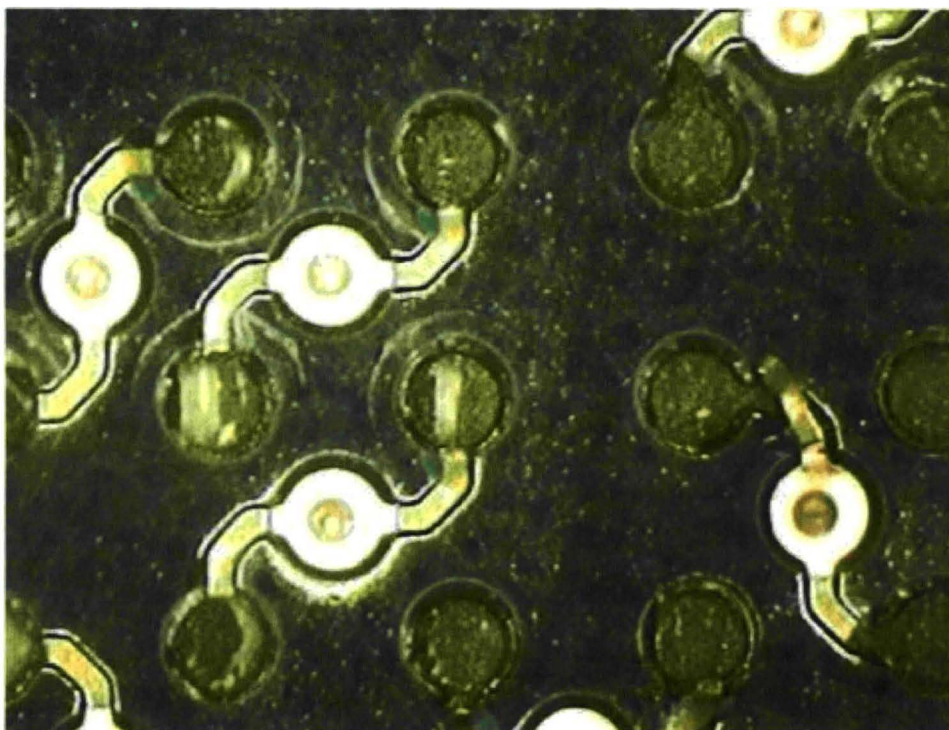
Surprisingly, on the SnPb/SnPb BGA's that fell off, almost 100% of the solder joints failed by pad cratering. The BGA balls and associated PWB copper pads were missing from the test vehicles (Figure 22 and Figure 23).

Figure 22 - Test Vehicle 30 BGA U2 with Missing Pads (SnPb Solder/SnPb Balls)

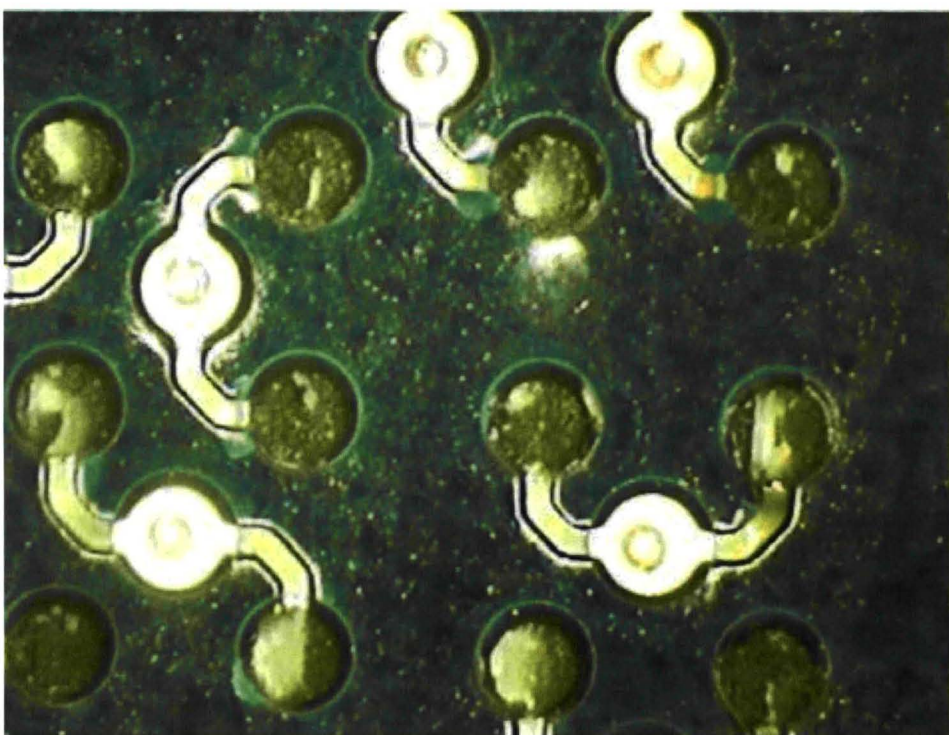
Figure 23 - Test Vehicle 30 BGA U4 with Missing Pads (SnPb Solder/SnPb Balls)

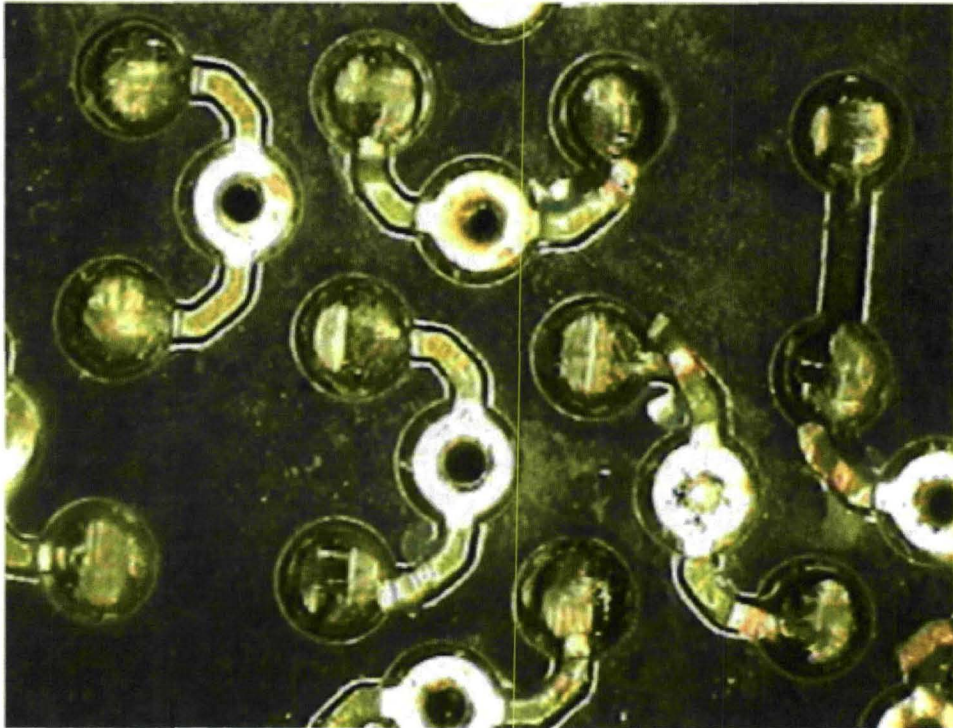
of the remaining balls also showed signs of PWB pad cratering). The balance of the BGA balls and associated PWB copper pads were missing from the test vehicle (Figure 24 and Figure 25).

Figure 24 - Test Vehicle 193 BGA U21 with Missing Pads (Flux Only/SAC405 Balls)

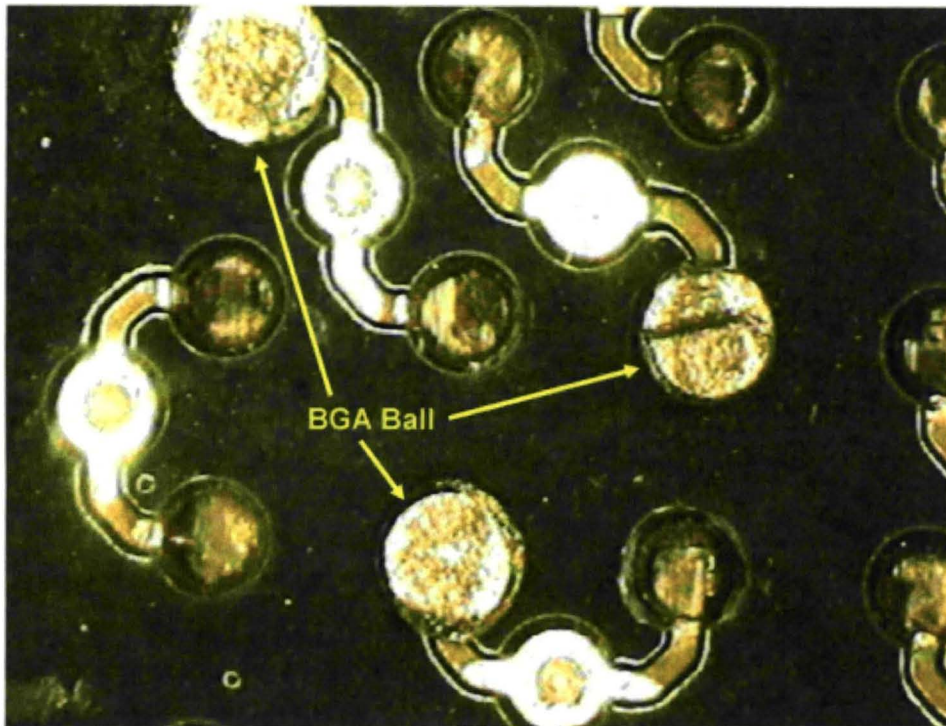
Figure 25 - Test Vehicle 193 BGA U21 with Missing Pads (Flux Only/SAC405 Balls)

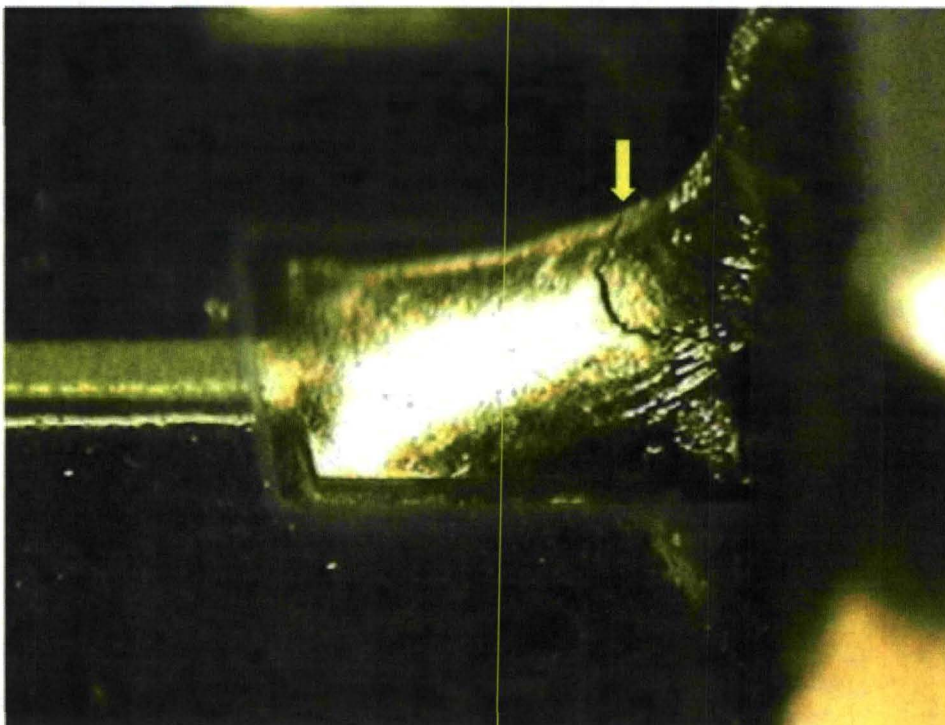
Test vehicle inspections made at the end of Mechanical Shock Testing showed cracks in a CLCC solder joint (Figure 27).

Figure 27 - Test Vehicle 191 CLCC U10 (Cracked SAC305/SnPb Solder Joint)

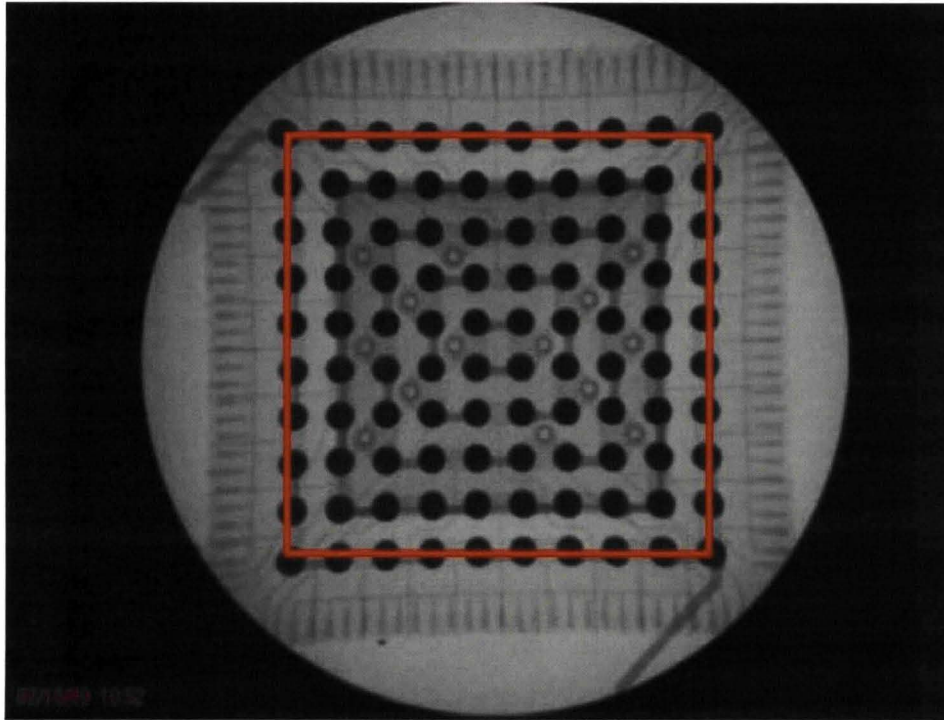
Figure 28 - X-Ray of a CSP-100

The CSP daisy chain pattern on the test vehicles was incorrect with the result that only the outer perimeter balls of each CSP formed an electrically continuous path (Figure 28). In order for a CSP to be detected as failed, both legs of the outer perimeter needed to fail.

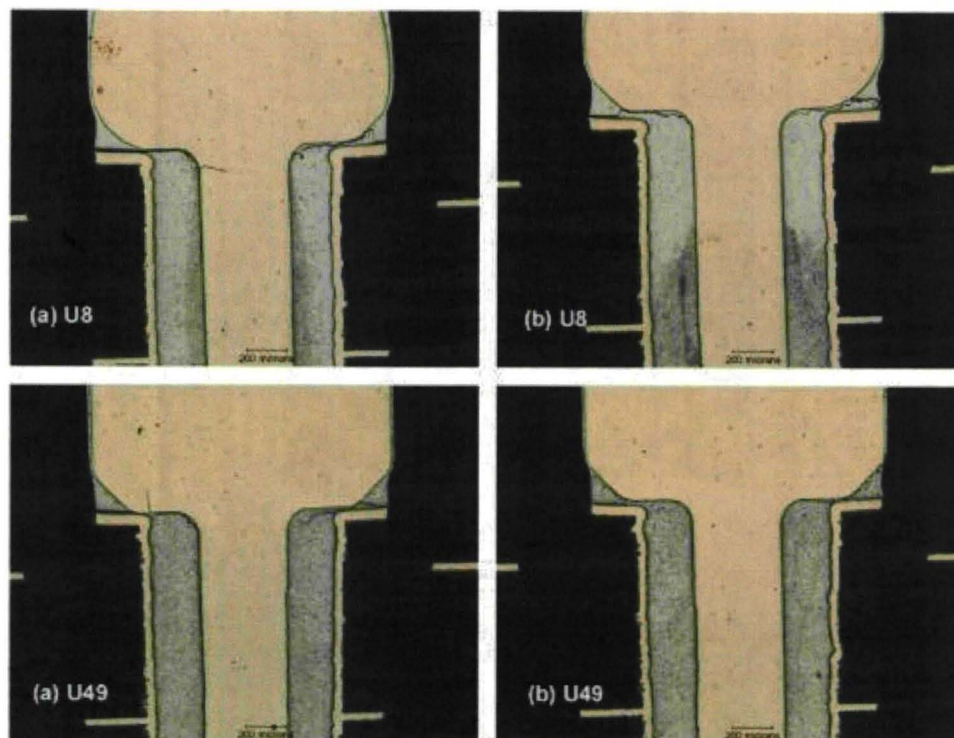
Figure 31 - Test Vehicle 34 – PDIPs U8 and U49 (a) Corner Lead, (b) Lead Adjacent to Corner Lead (SnPb Solder/SnPb Finish)

The combination of SN100C solder/Sn component finish generally performed as well as the SnPb/SnPb controls in mechanical shock although some of the SN100C/Sn solder joints failed early. Microsections made at the end of the test showed that the corner solder joints failed before the other solder joints. The topside solder fillet would crack first followed by cracking of the lead where it necks down at the top of the PTH (Figure 31 and Figure 32).

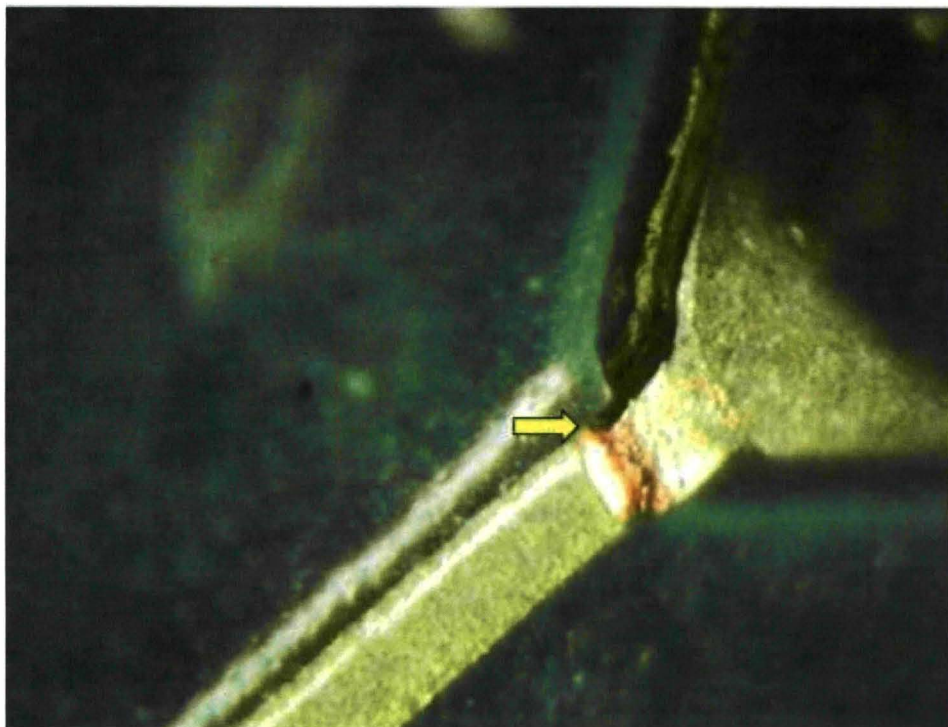
Another observation is that many of the PDIP's soldered with SN100C exhibited trace cracking at the corner solder joints (Figure 33 and Figure 34). This failure mode was not observed as often with the PDIP's assembled with SnPb solder.

Figure 33 - Test Vehicle 89 PDIP U30 (Cracked Trace, SN100C)

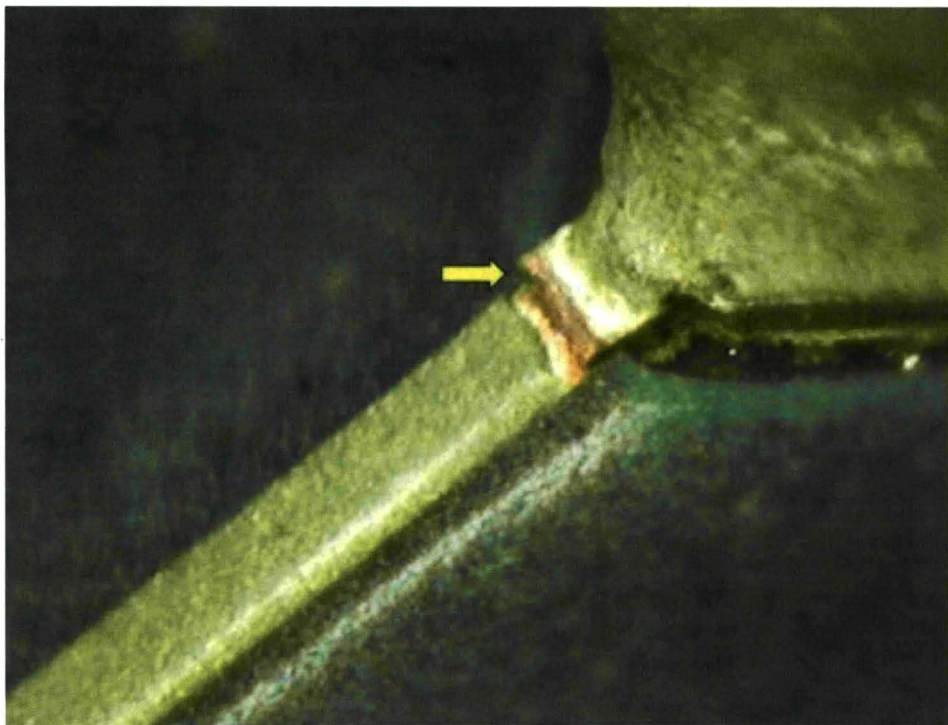
Figure 34 - Test Vehicle 89 PDIP U38 (Cracked Trace, SN100C)

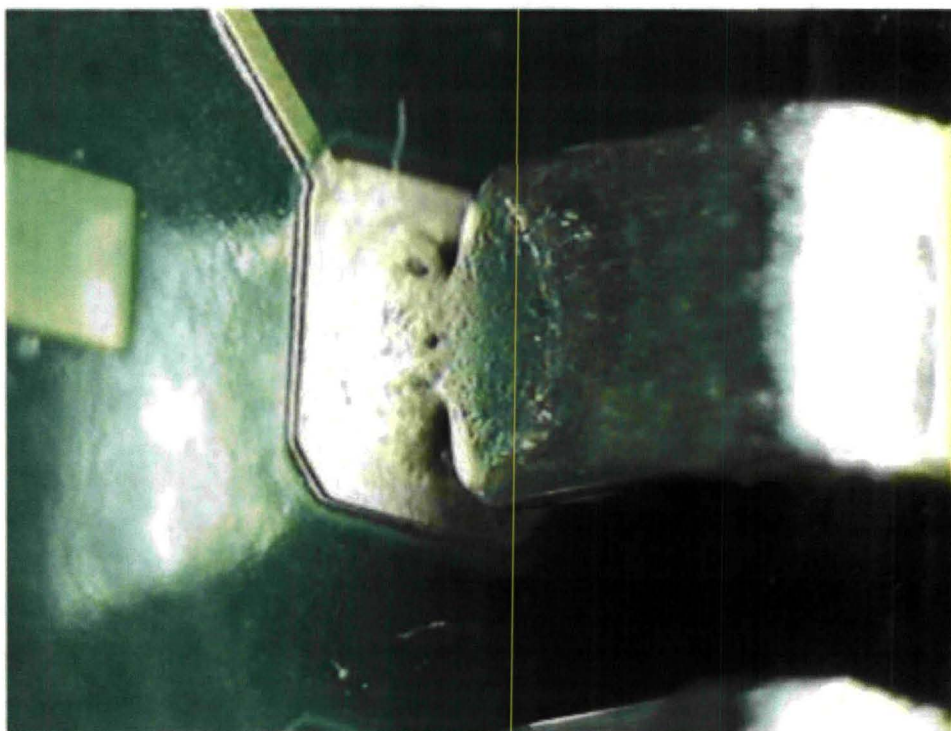
Figure 35 - Test Vehicle 89 PDIP U51 (SN100C)

Several of the earliest failures on the “Manufactured” test vehicles were SN100C/Sn solder joints. One possible cause is that some of the SN100C joints did not have a substantial topside solder filet (Figure 35). This could have resulted in a point of high stress concentration where the PDIP lead necked down resulting in premature failure of the lead. The trace cracking mentioned above is another possible cause for the early failures. Many of the PDIP’s that failed early exhibited both failure modes so it could not be definitely determined which occurred first.

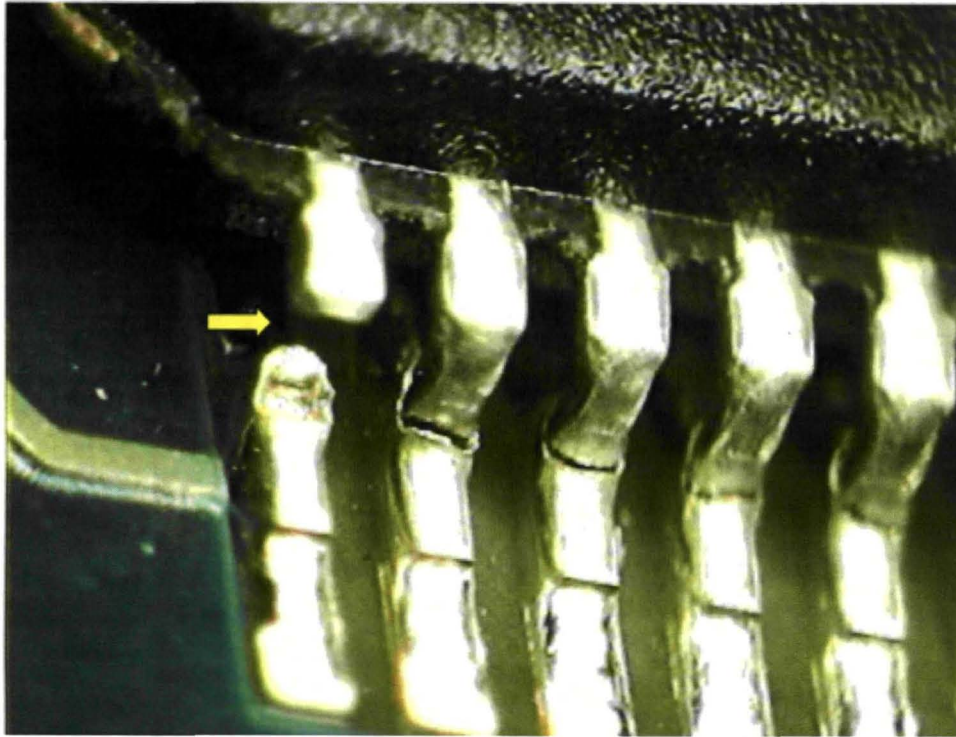
Most of the TQFP-144’s had broken and/or missing leads at the end of the test (Figure 36). Since most of the failures appeared to be due to broken leads, the scatter in the test data for all of the TQFP solder/finish combinations was small. SAC305/Sn was equivalent in performance to SnPb/Sn, SnPb/NiPdAu (on immersion Ag), and SnPb/NiPdAu (on ENIG). SAC305/NiPdAu was superior to the SnPb/Sn controls in performance.

Figure 36 - Test Vehicle 89 TQFP U3 (Cracked Leads, Missing Lead)

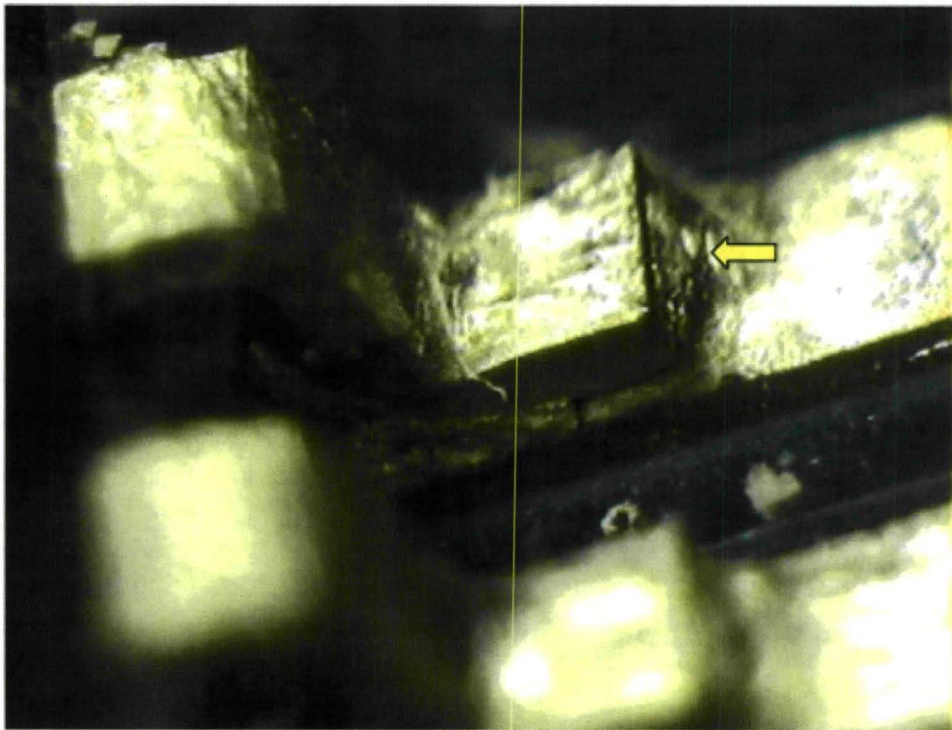
Test vehicle inspection made at the end of Mechanical Shock Testing showed cracks in a TSOP solder joint (Figure 40).

Figure 40 - Test Vehicle 34 TSOP U61 (Cracked SnPb/SnPb Solder Joint)

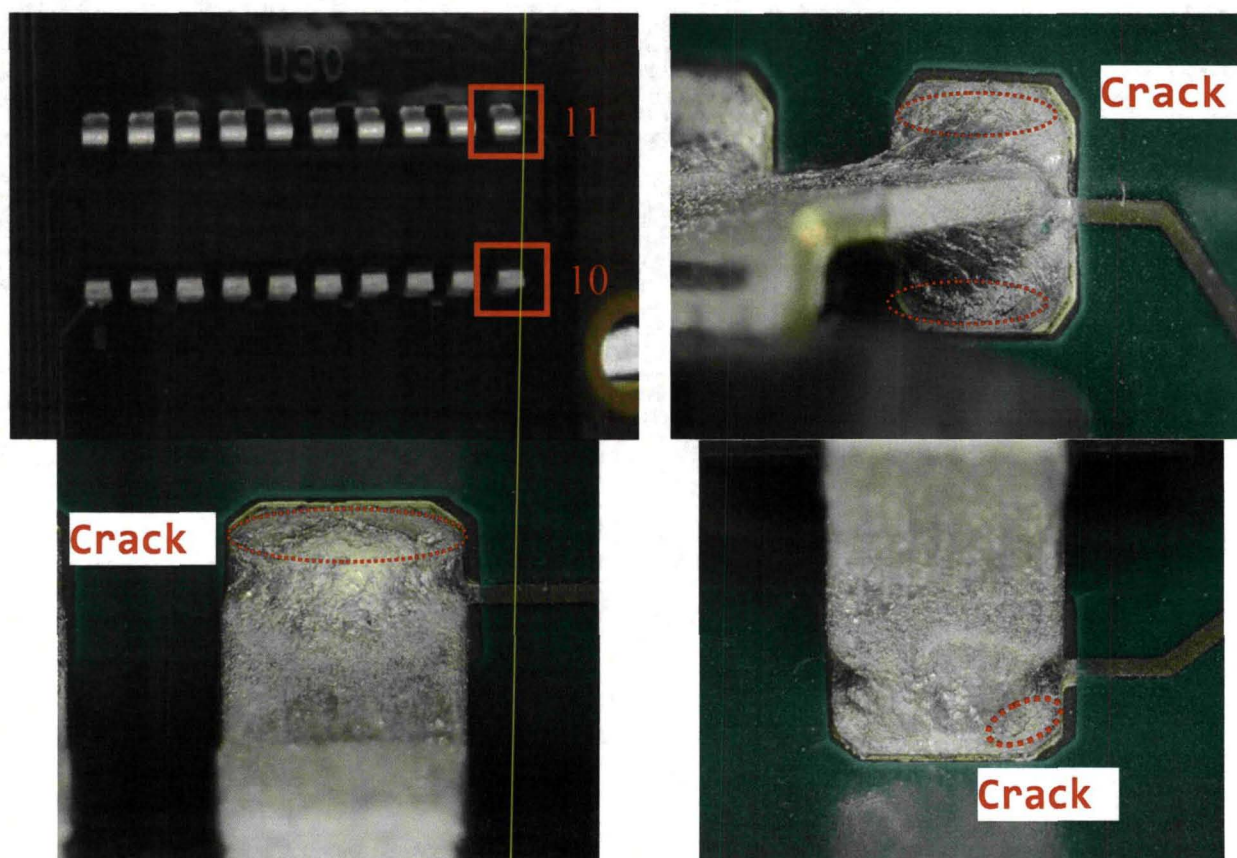
Figure 45 - TV23 U30; Optical Micrograph, PDIP-20

Figure 45 is an optical micrograph of a PDIP-20 component. The red boxes highlight the two leads that were magnified to indicate observed cracking in the solder joints. The image in the upper right is of lead 11, which indicates two areas with cracking. The image in the bottom left is the top portion of lead 11 and the bottom right image is of lead 10 showing a small crack near the pad. Crack has not caused an electrical failure, yet.

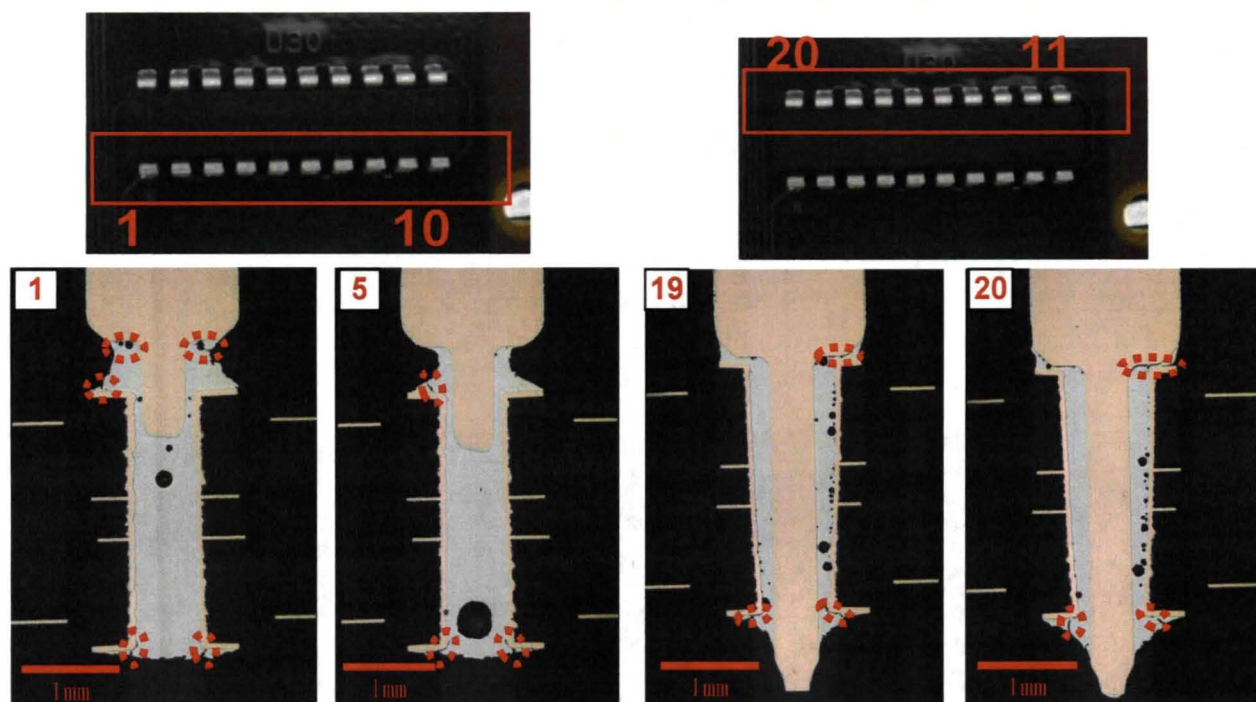
Figure 46 - TV23 U30; Cross-Sectional Micrographs of PDIP-20 Leads

Figure 46 shows cross-sectional micrographs of PDIP-20 leads where the two images on the top are indicating the lead numbering. The cross-sections of leads 1, 5, 19 and 20 were selected as an example of the leads that had large quantities of voids, relative to the other component leads. The dotted lines indicate solder cracks that were found; no break off solder was found during failure analysis.

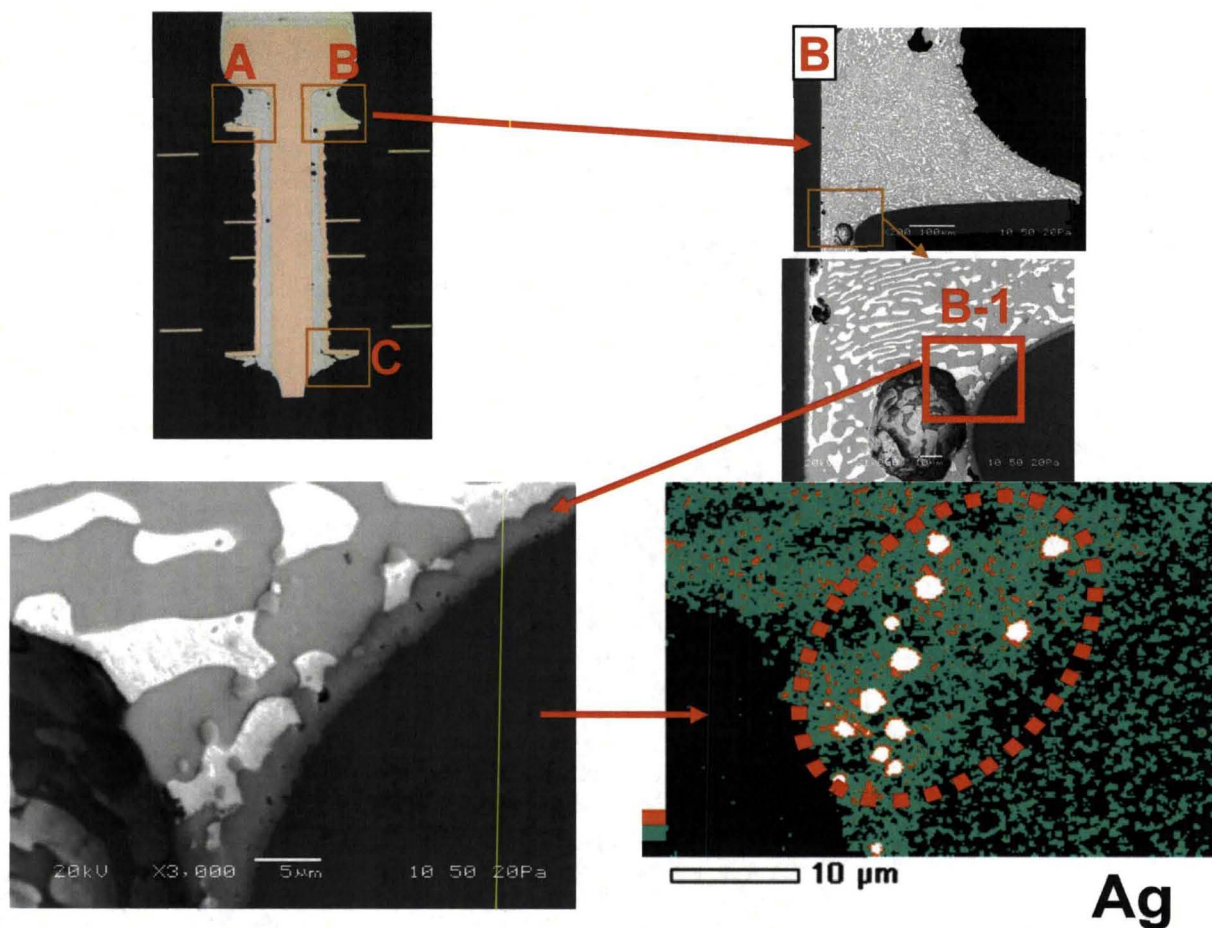
Figure 47 - TV23 U30; Micrographs, Lead 9 of PDIP-20

The micrographs in Figure 47 show progression of analysis for lead 9 of PDIP-20 component beginning with upper left and following the arrows to the image on the bottom right. This analysis found silver (bottom right) within the solder joint. The source of the silver may have been the immersion silver board finish.

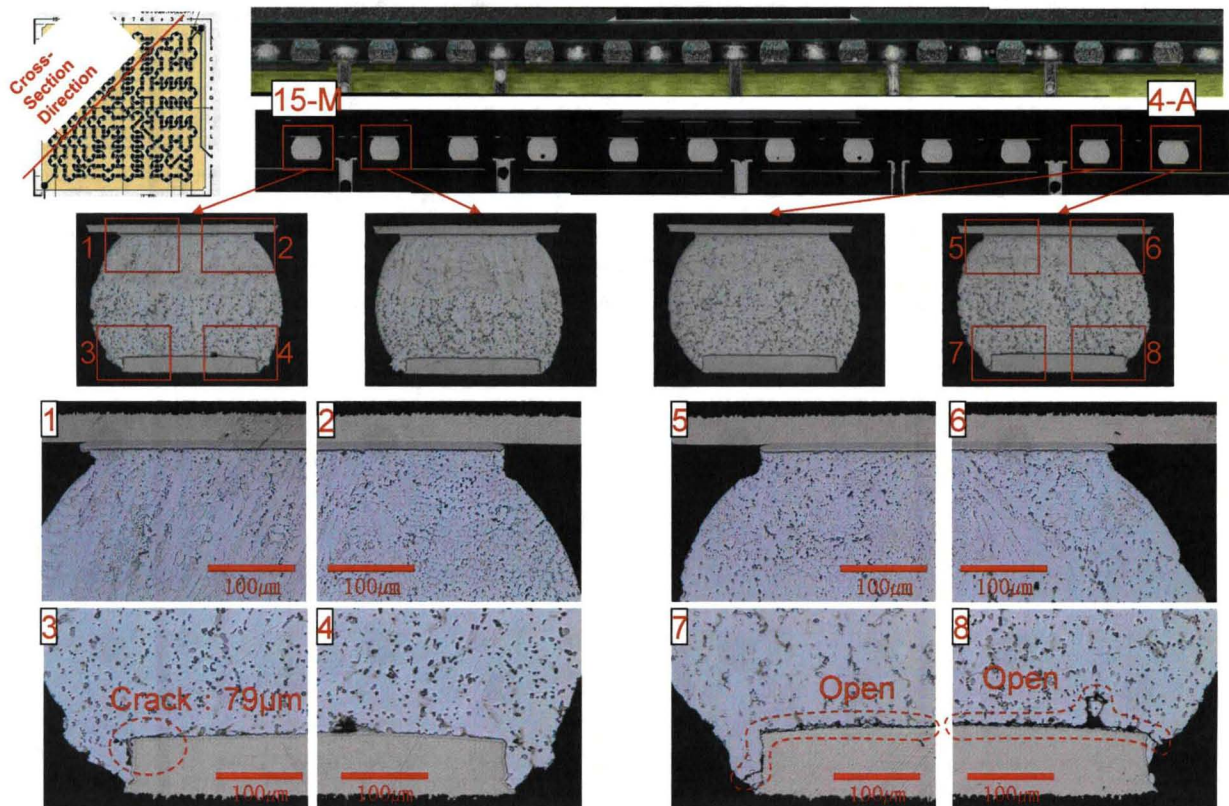
Figure 49 - TV23 U43; Cross-Sectional Micrographs

Cross-sectional micrographs in Figure 49 show different solder structure in lands on board (3, 4, 7, 8) and lands on component (1, 2, 5, 6). Cracking to open along land on board observed at 3-A.
